**U.S. Immigration  
and Customs  
Enforcement**

**OFFICER SAFETY ALERT –  
COUNTERFEIT LITHIUM BATTERIES**

## PRC SureFire Counterfeit SF123A Primary

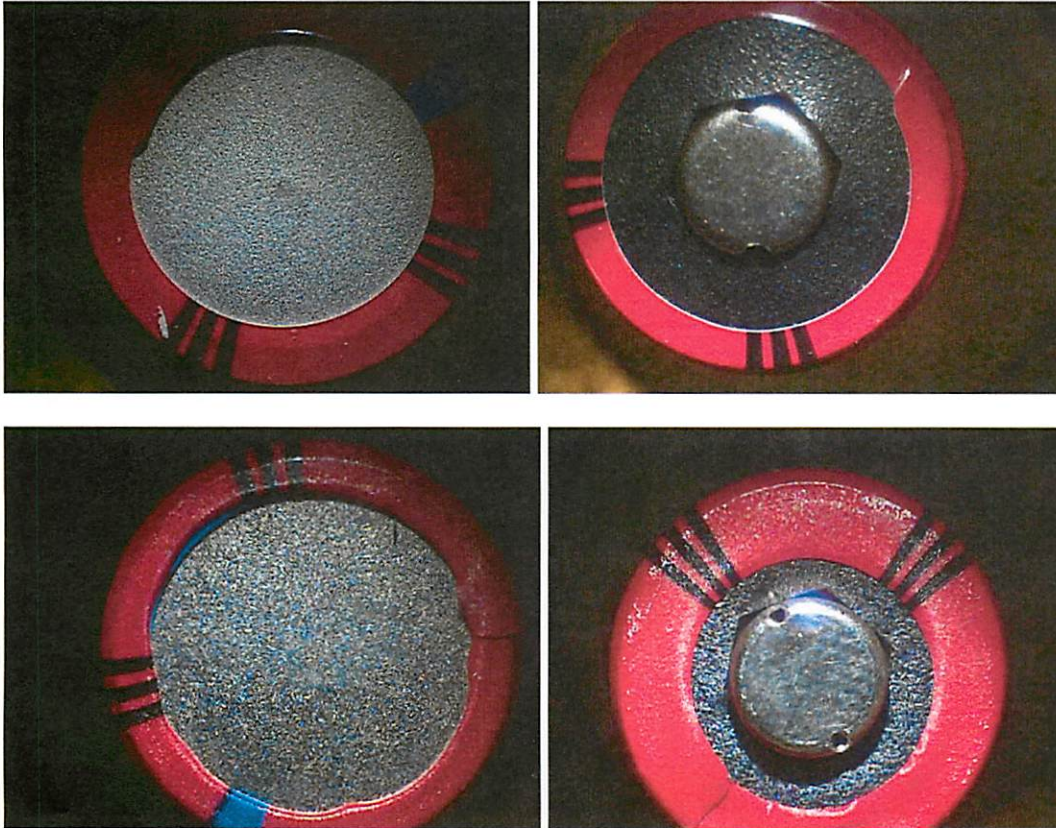
1. Surface appearance of metal not same.
2. Anode configuration not same, through holes are in different locations and are different sizes.
3. Outer insulation overlap dissimilar in size and location.
4. Outer insulation edge overlap(top & bottom) opposite configuration of original.
5. Graphics (lines) incorrect width and spacing.
6. Blue graphic only bordered on one side by black, original has black on both sides of blue edge.
7. Overlap joint/seam is wavy and cut straight on top, original joint straight edge and angled on top.

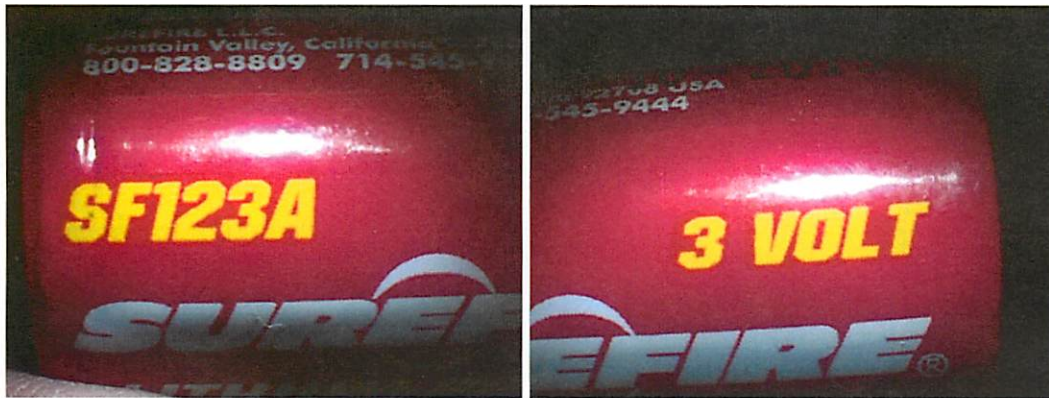
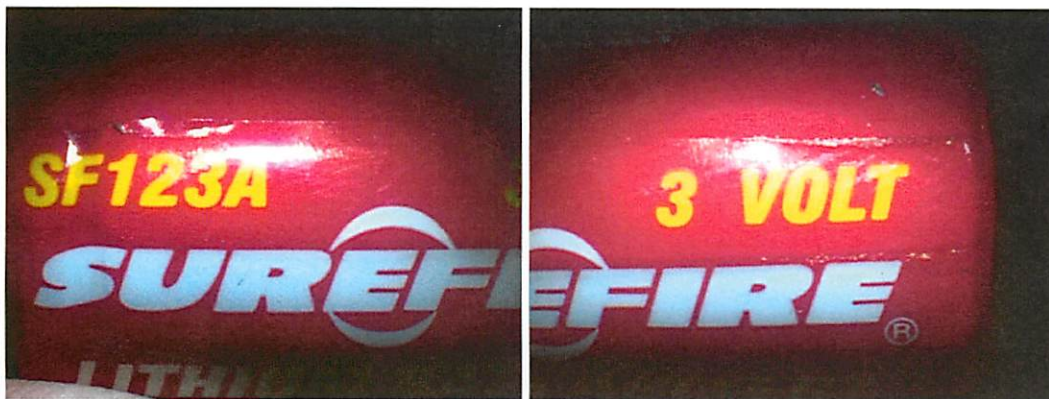
1. Reflectance of the material more iridescent
2. "SF 123A" in different position
3. Seam is not consistent with original, overlap noticeable.
4. Font and curving dissimilar.

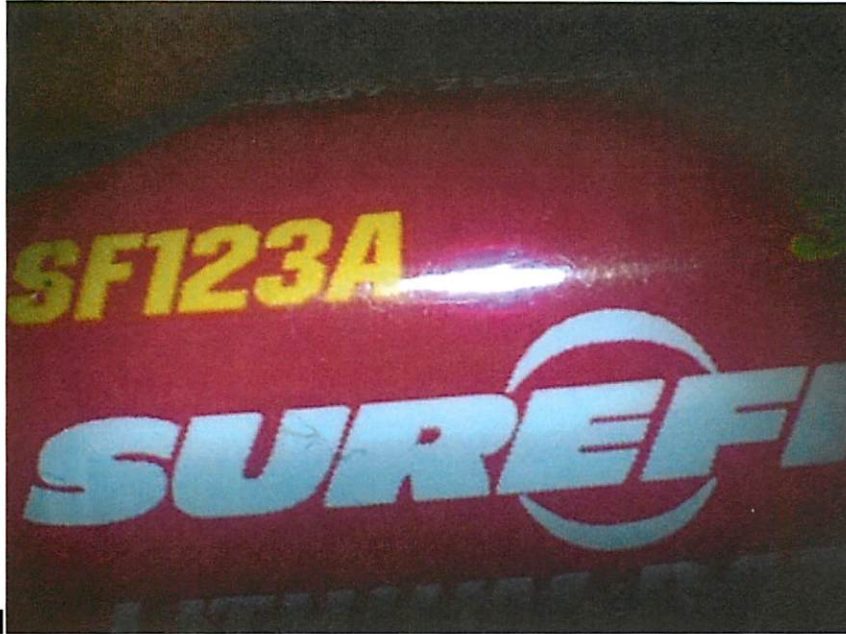
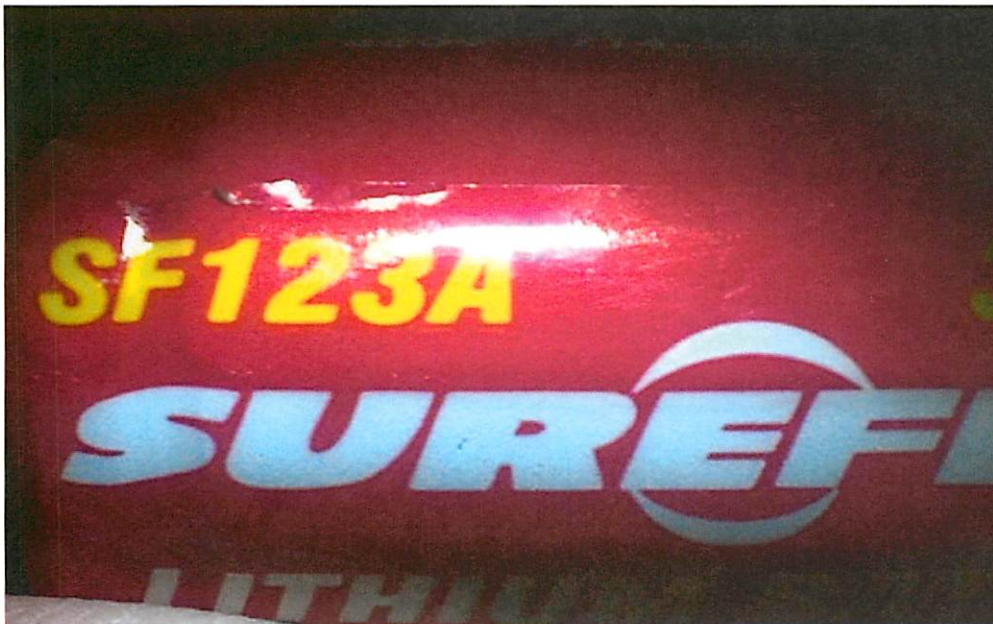
SureFire Original

Edges of the characters are not deckled. Graphic circle radii incorrect, terminations at "E" & "F" wrong, positions invade character bodies at bottom of "E" / "F" and right top of "F". Font and spacing of "R", "E", and "F" dissimilar. Radii of the "U" dissimilar, finger spacing of the "E" & "F" not straight, have been hand cut.

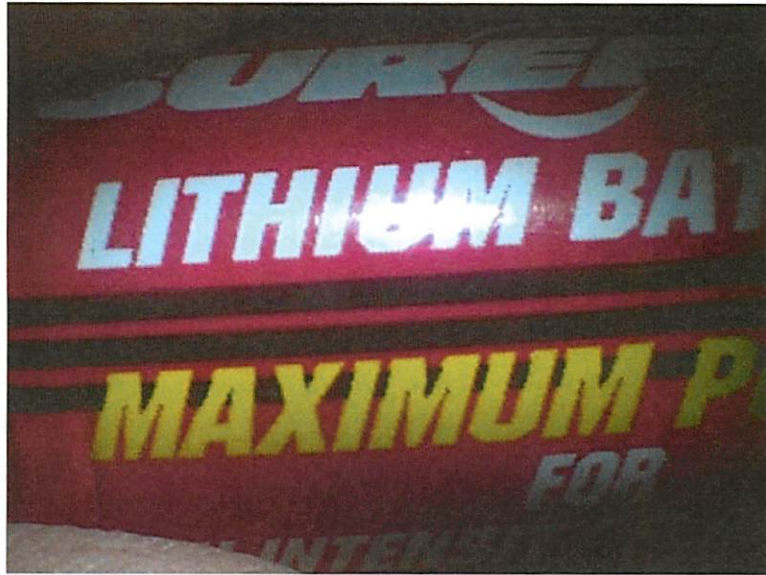
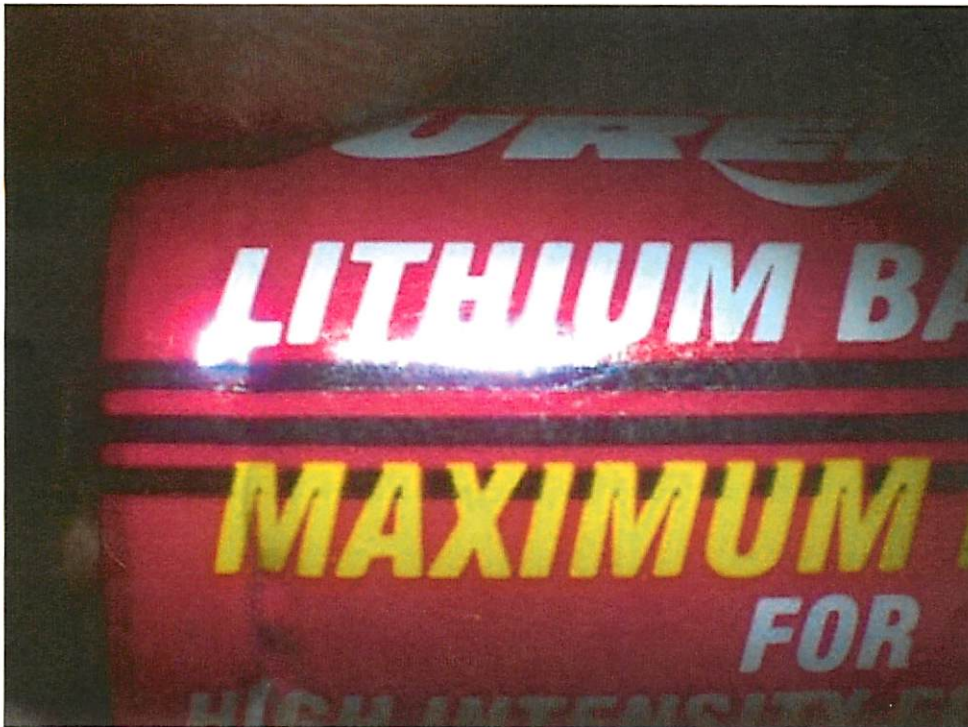
Font and word positions as opposed to the graphic stripes are not correct (U). Stripe width and spacing further apart.

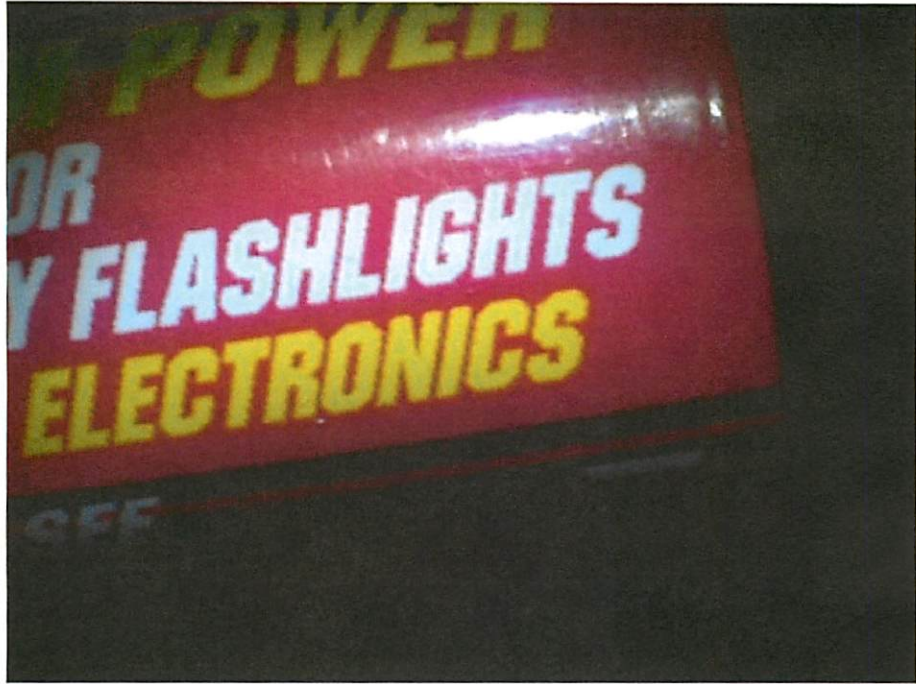
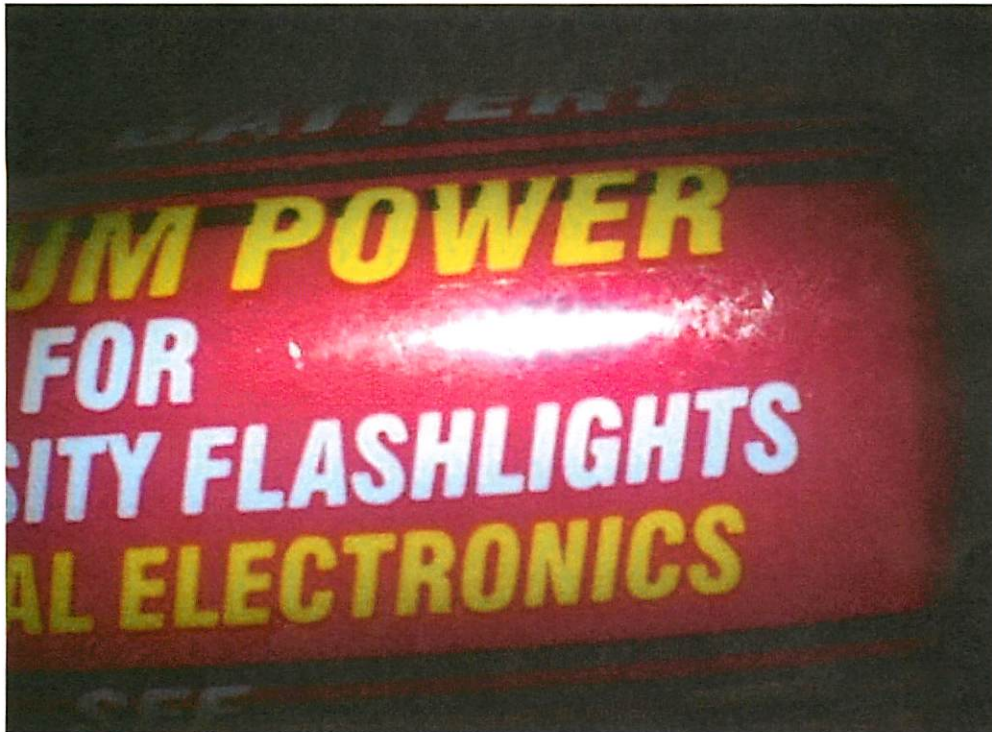
Dissimilar fonts

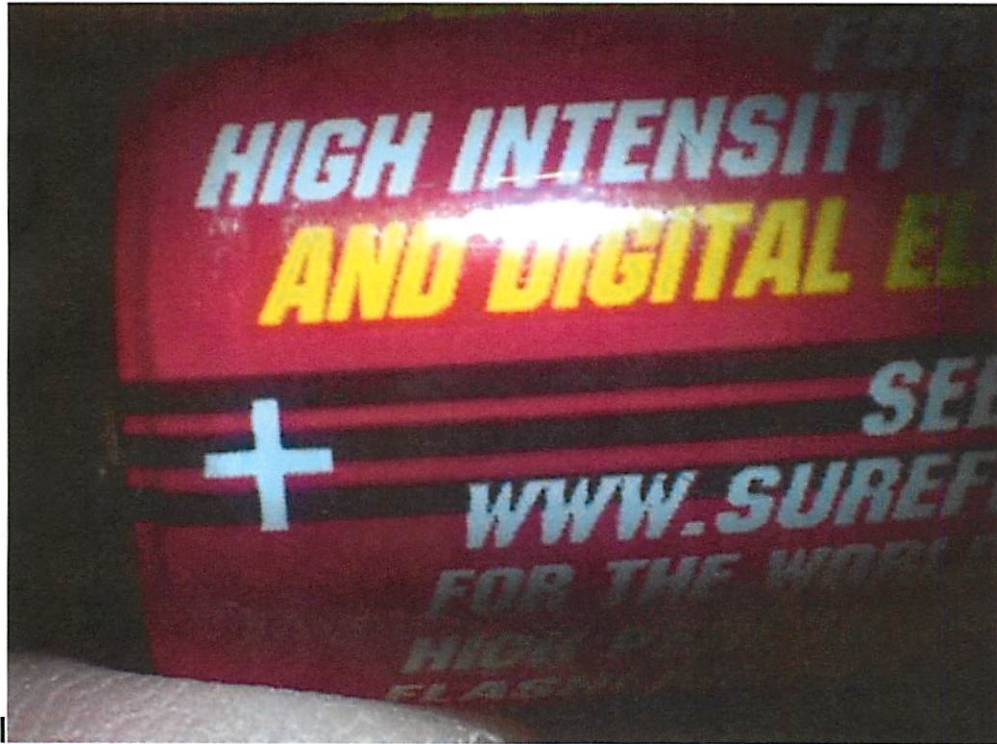
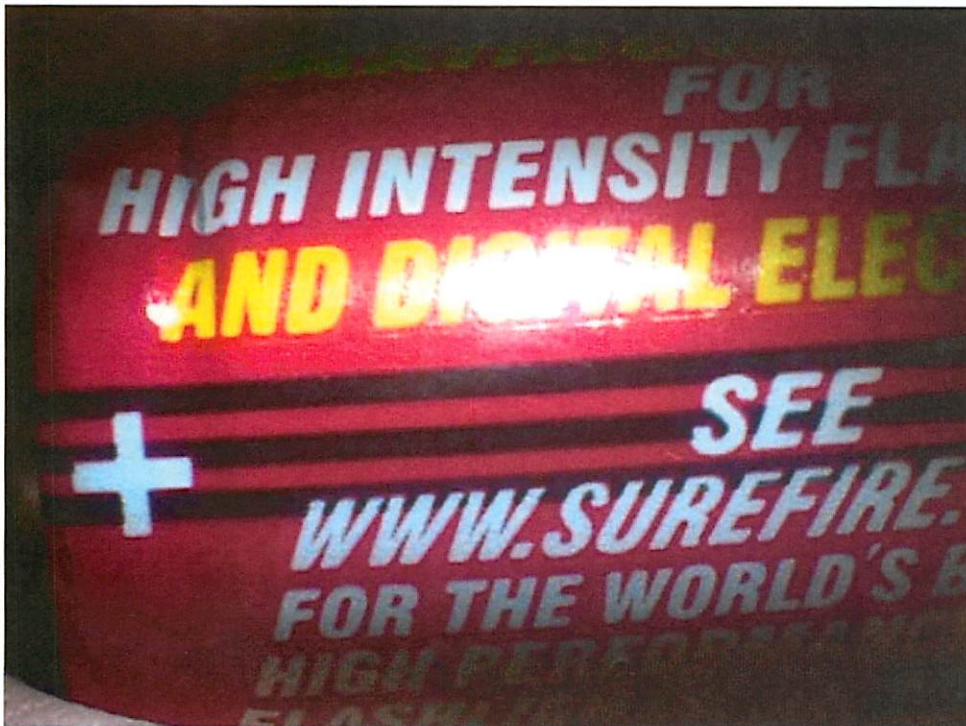
Dissimilar font, "+" sign, web site and "SEE" size and placement.

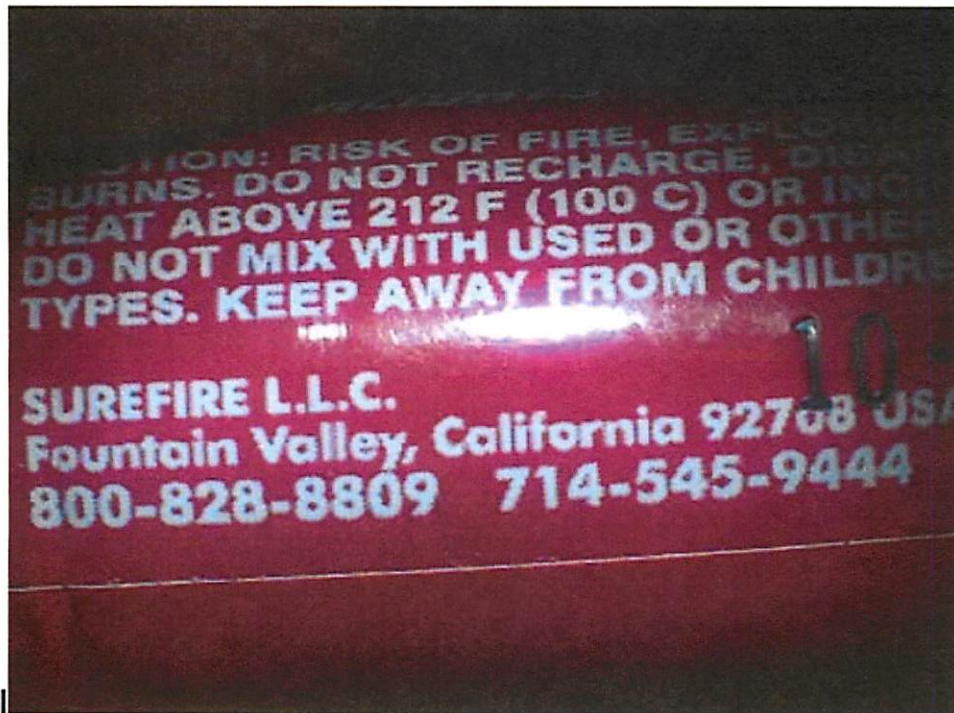
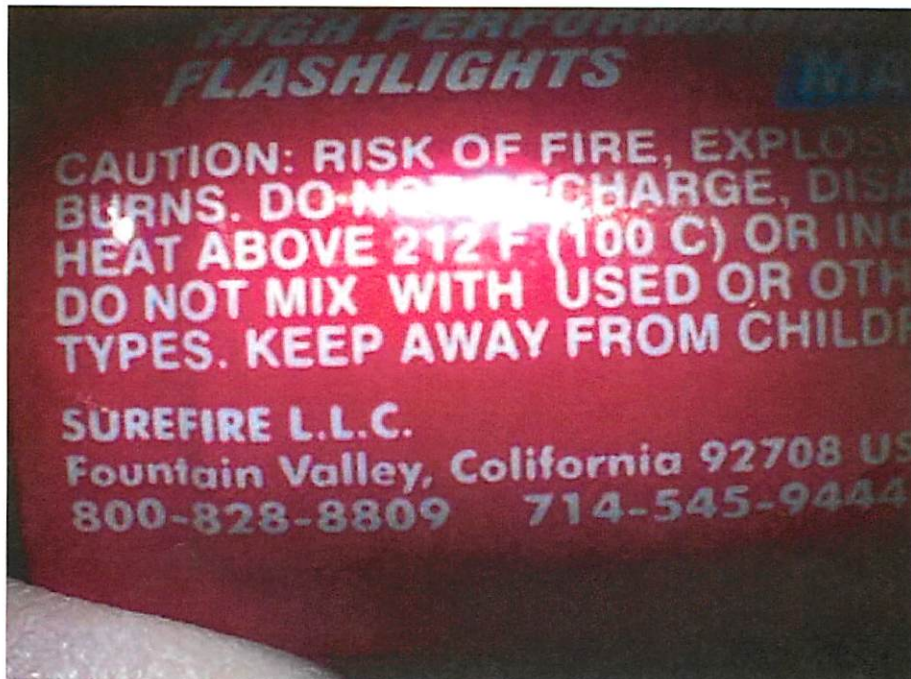
“California” misspelled “Colifornia”, missing date stamp.

Overlap seam is not in correct position 180° out of position.

“Used” joins the “( 100 C)”.

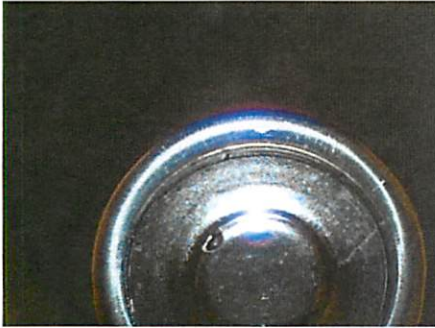
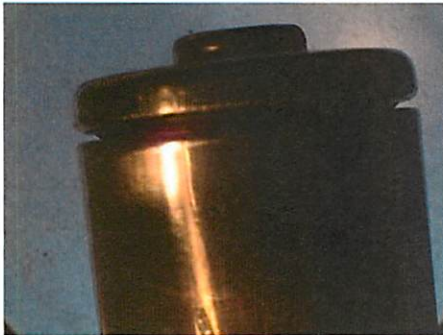
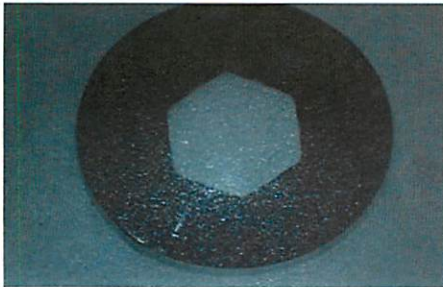
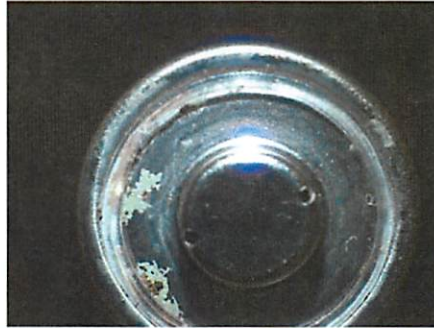
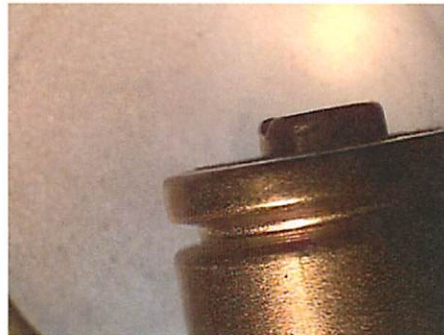
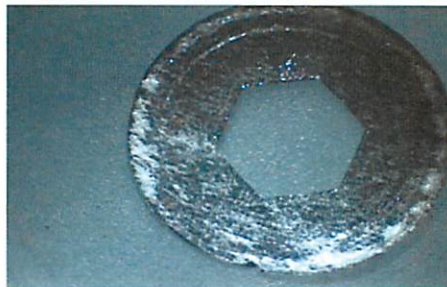
#### Configuration/construction dissimilarities:

1. Vent holes
2. Top Edge Crimp
3. Top PTC Crimp
4. Adhesive insulation washer

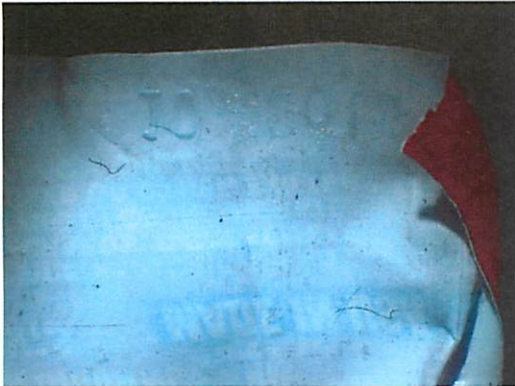
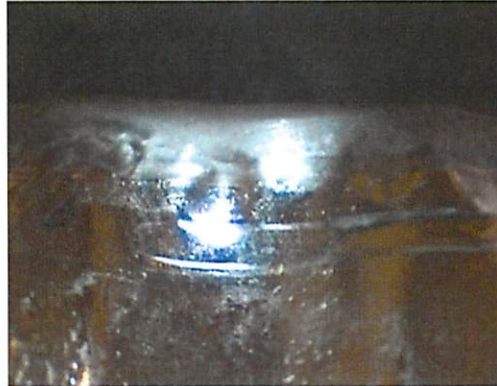
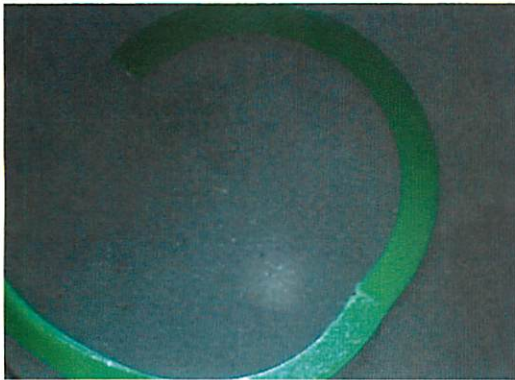
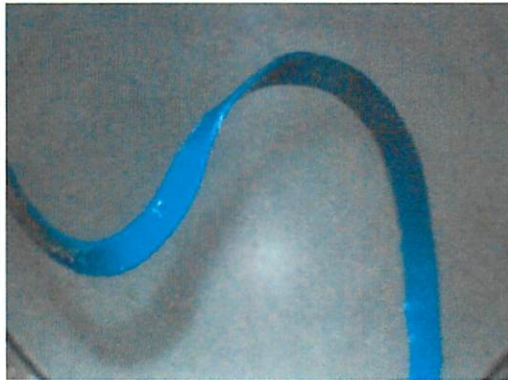
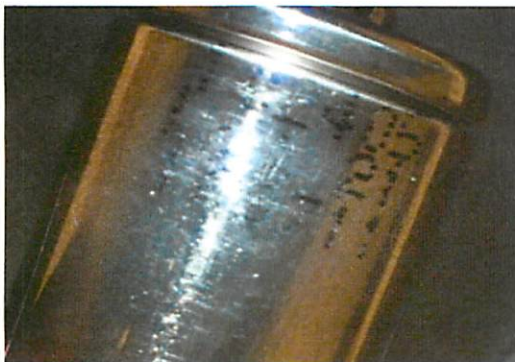
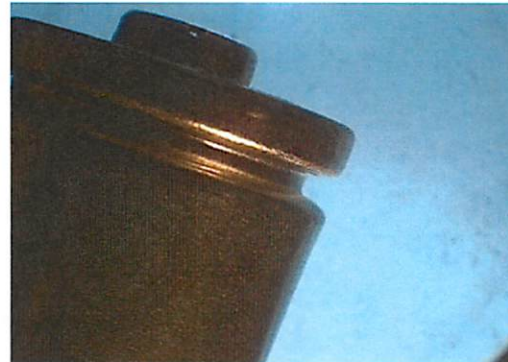
Material Dissimilarities:

1. Foil printed
2. Spacer color and material
3. Missing date stamp
